**NASA TECHNICAL
MEMORANDUM**

POST TEST INSPECTION OF THREE BRAYTON ROTATING UNITS

by James H. Dunn
Lewis Research Center
Cleveland, Ohio

TECHNICAL PAPER proposed for presentation at
1971 Intersociety Energy Conversion Engineering Conference
sponsored by the Society of Automotive Engineers
Boston, Massachusetts, August 3-6, 1971

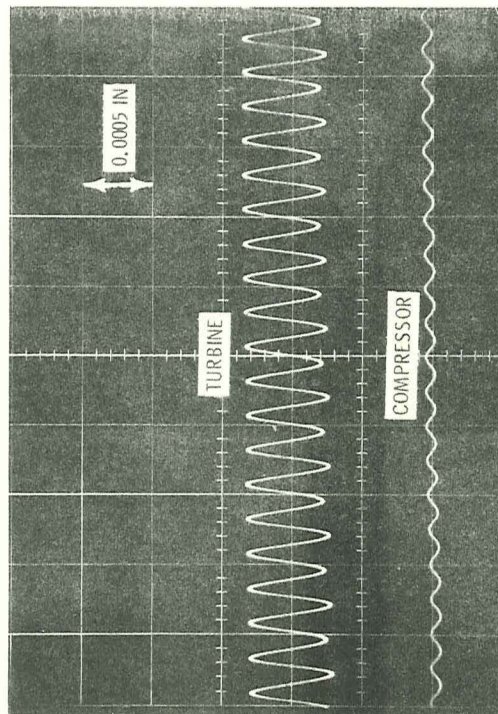
Figure 5. - Radial motions of flexibly mounted pads and pivots; turbine and compressor journal bearings. Pneumatic instability; bearing pressure ratio, 16; zero speed. Externally pressurized.

Reference 2 also describes a pneumatic instability that occurred in the turbine and journal bearing during hydrostatic operation when the pressure ratio - prior to startup - between the bearing hydrostatic supply pressure and the bearing ambient pressure exceeded 10. Figure 5 is the picture of an oscilloscope trace of the

radial motion of the flexibly-mounted pad and pivot observed at zero speed and a bearing pressure ratio of 16. The top trace is the turbine end pivot with radial motions of 0.0006 in. and the bottom trace is the compressor pivot with radial motion of 0.0001 in.

This anomaly has not been observed in the three other units that have been tested. It does not present an operational problem because the unit, when operating in the Brayton Engine, is started with the bearing pressure ratio below 10.

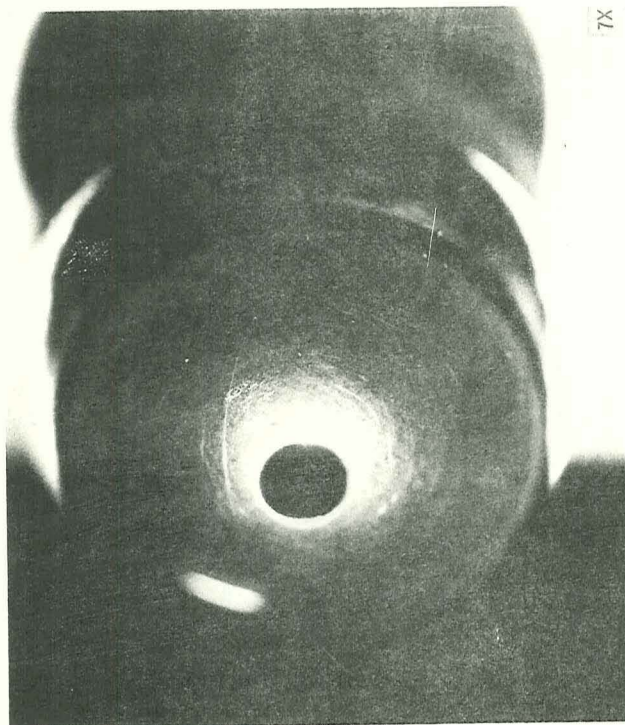
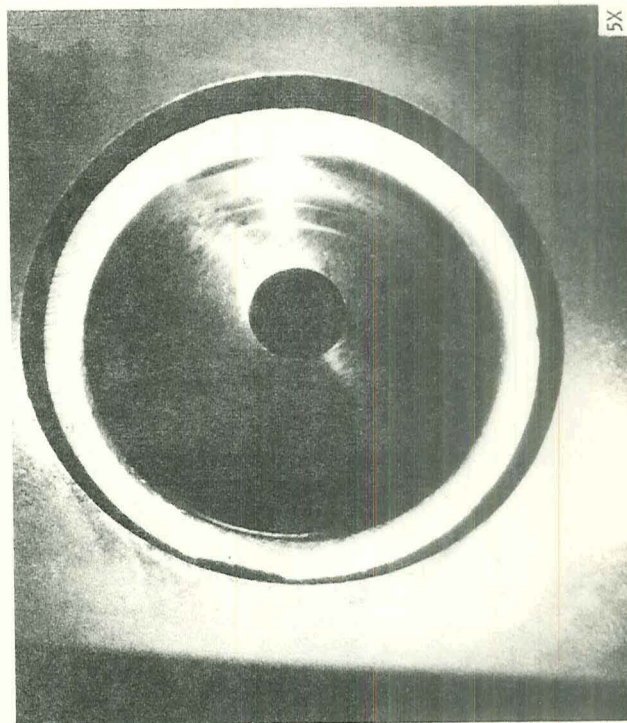
Figure 11. - Photomicrograph of rigid mounted ball and socket showing minor surface damage areas.

Inspection of the bearing pivots revealed identical amounts of minor surface fretting or roughness on all the pivot surfaces. The turbine end flexible pivot however also contained a small localized area of more extensive damage.

Figure 11 shows a typical pivot pair. The fretted areas were uniformly distributed over the total contact area indicating a good mechanical fit and uniform load distribution. To the naked eye, these areas appeared to be surface stains and covered about 25 percent of the total contact area. Figure 12 is a typical Talysurf trace taken on a pivot ball. Looking at the trace, it is difficult to distinguish the fretted surface from the original surface roughness of $2\ \mu$ in. It can, however, be concluded that the peak-to-peak roughness was no greater than $4\ \mu$ in. Figure 13 is a picture of the turbine end flexible pivot showing the additional damage area in that pivot. Figure 14 is a Talysurf trace taken across that area and shows that the maximum depth of

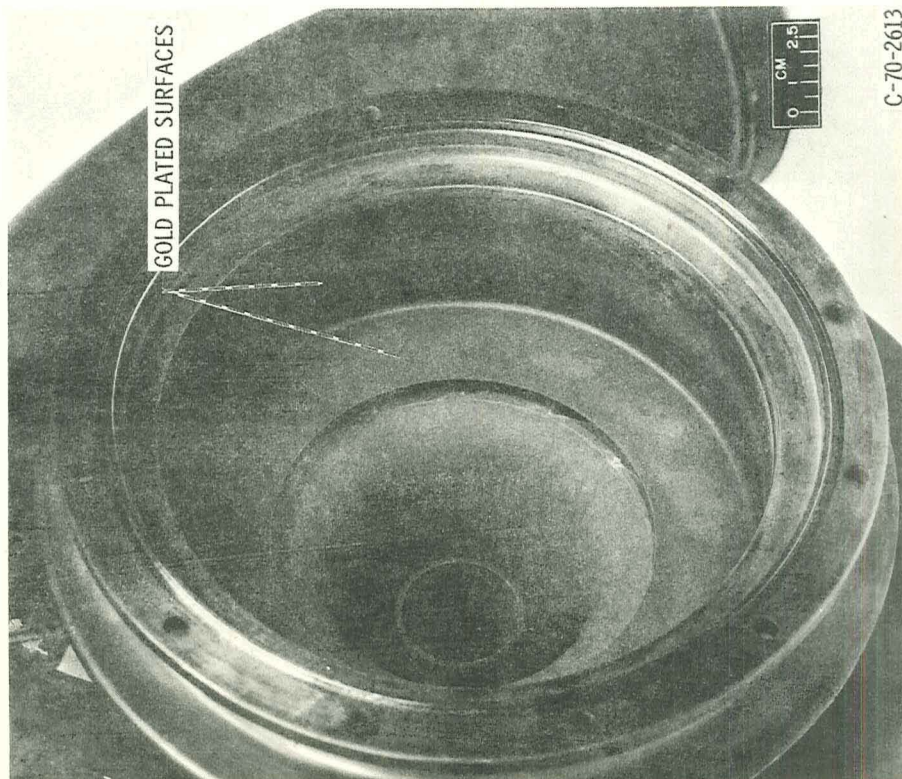
Figure 10. - Turbine scroll.

Those parts exposed to the hot turbine gas were coated with a thin oxide coating that ranged in color from light gray to black. Spectrographic and X-ray diffraction analysis indicated that the prime constituent in the coating was manganese metaborate. Color was a function of the coating thickness; the thicker the coating, the darker the color. The origin of the boron is as yet unknown although boron did exist in the braze material used to braze the headers to the manifold in the electric heat source. The significant aspect of the oxide coatings is that two of the surfaces coated by the oxide had been plated to minimize radiant heat transfer. The seal and shroud assembly shown in Fig. 9 was rhodium plated, and a portion of the back of the turbine scroll shown in Fig. 10 was gold plated. The design objective of these plated surfaces was obviously negated by the oxide film, however, there was no apparent change in performance or internal temperatures of the unit.

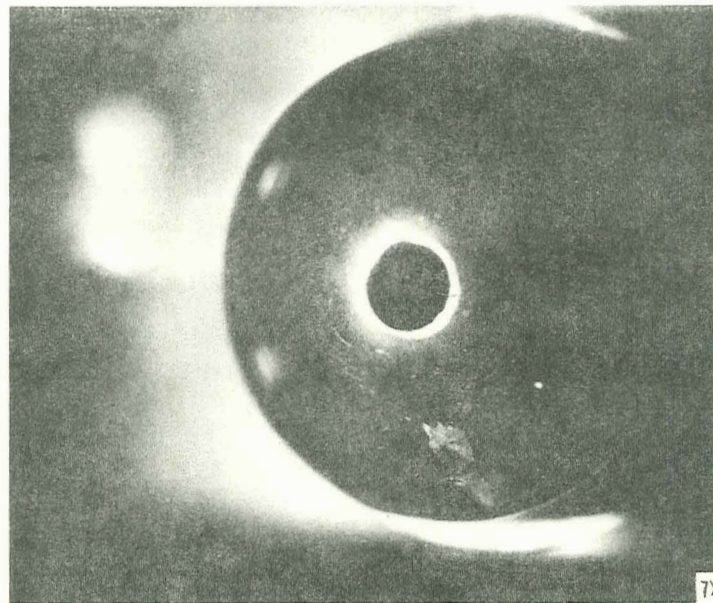
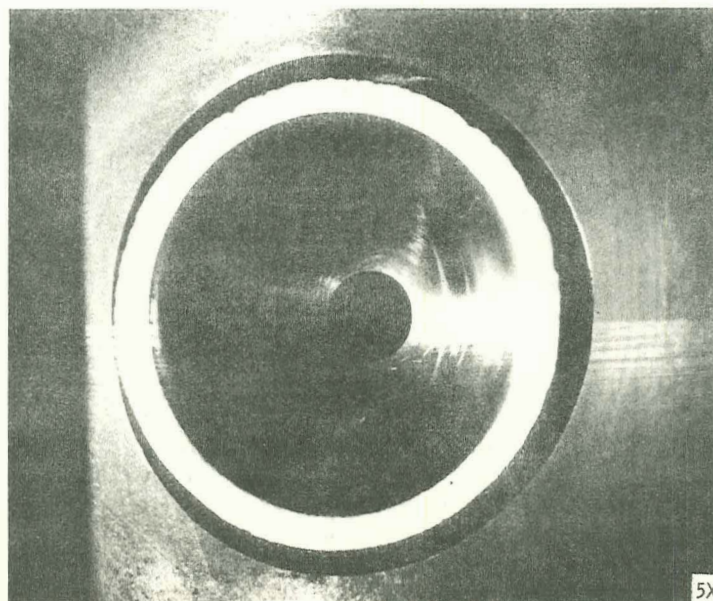
Figure 13. - Photomicrograph of flex mounted pivot ball and socket showing surface damage (turbine end).

Microscopic examination of the material formation at the edges of the damage area indicated that the damage was the result of abnormal loading conditions in the pivot. The observed material deformations were those resulting from relative motions normal to the surface which could occur only with changing loads. Material has been plucked from the surface with no evidence of smearing that would result with sliding. The pivots are designed to operate under constant load with pure sliding motion. There is little question but that the above damage was the result of the severe abnormal motions and loading conditions to which the pivot was subjected in the extensive investigation of the pneumatic instability during the component test phase.

The contacting surface of the friction dampers on the thrust bearing gimbal showed no signs of wear. The unit has been reassembled with a new turbine end flexible shoe and beam mount. It has been cold tested to rated speed prior to reinstallation in the Brayton engine for continued testing.

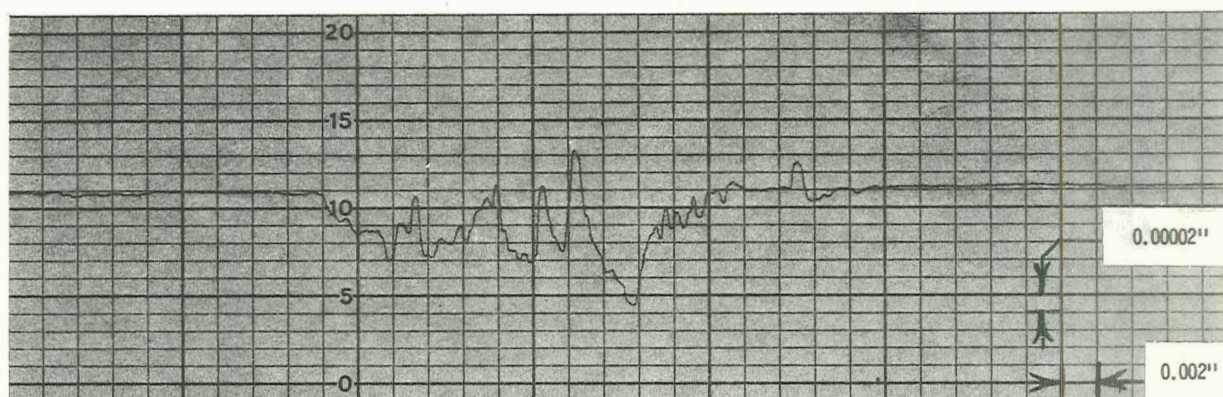
Figure 14. - Photomicrograph and Talysurf trace of surface damage on flex mounted ball (turbine end).

damage was $130\ \mu$ in. Comparing the areas under the curve above and below the base line (surface) it can be seen that most of the damaged material has been removed from the surface. The matching area in the socket was similar, indicating that the damage debris worked its way out of the pivot.

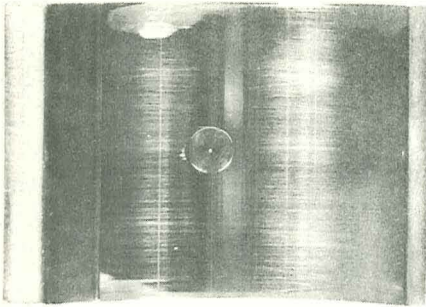
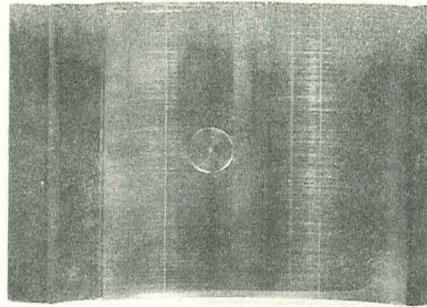
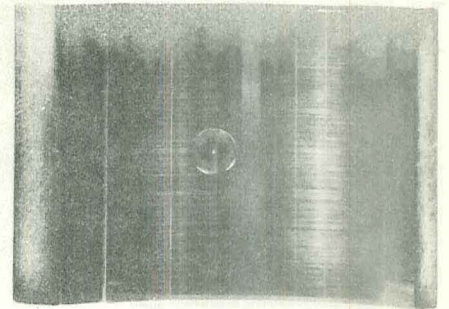
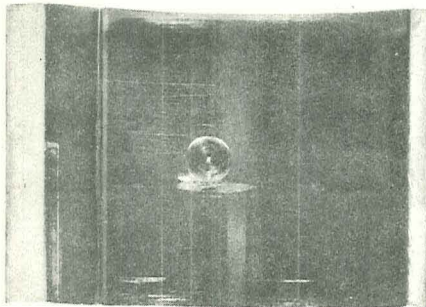
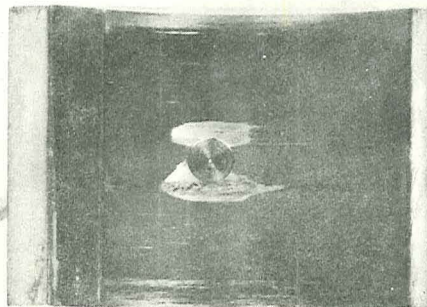
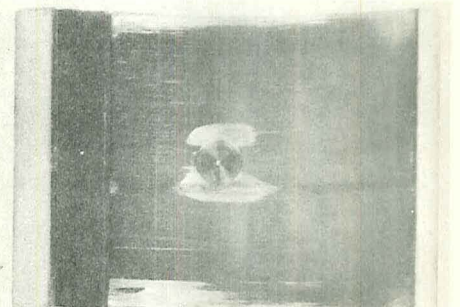
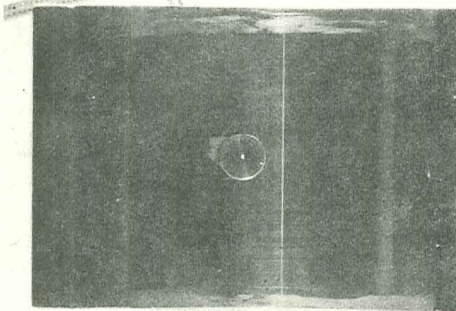
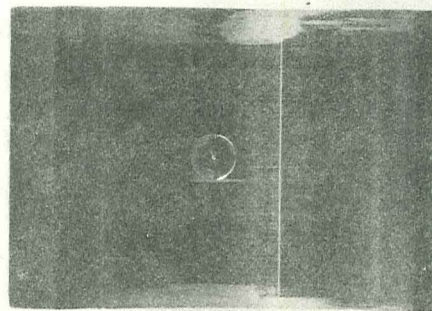
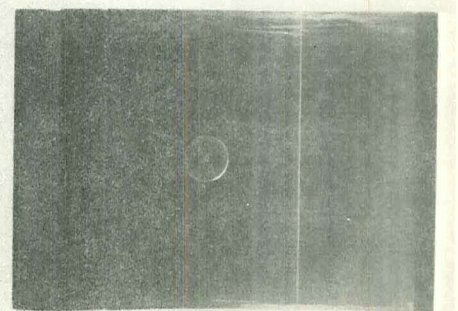
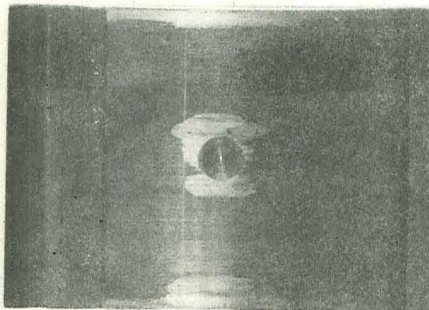
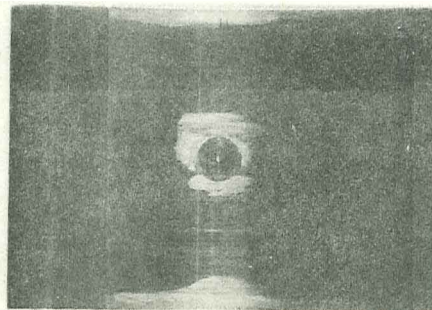
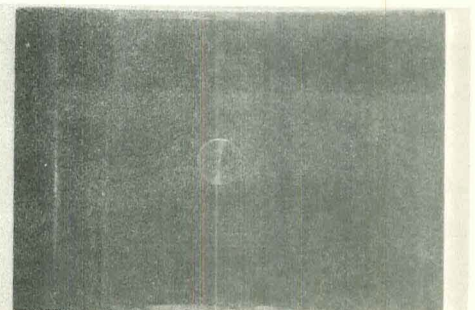
Figure 15. - Overspeed damage to journal bearing pads.

BRU-1 AND BRU-3 - BRU-1 and BRU-3 were disassembled after overspeed bearing seizures. Both overspeeds were the result of problems external to the BRU that caused sudden removal of the alternator load while under power. The results were almost identical in both cases. The BRUs accelerated to above 50,000 rpm in about 20 sec. Sudden stoppage due to bearing seizure occurred at 52,000 rpm (140 percent of design speed). Inspection, which included a dimensional check of all parts, revealed that the damage in both units was identical and was limited to the shaft journal coatings, the bearings, the labyrinth seals, and eight capacitance probes in each unit (4 orthogonal and 4 thrust). The damage sustained by the journal bearing and seals was minor, with the thrust bearing absorbing the energy of the sudden stop. The limit of the damage suffered by the journal bearings shown in Fig. 15 was demonstrated during the disassembly. After removal of the thrust bearing, external pressurization was applied to the journal bearings and the shaft rotated freely.

sor side was identical. Damage was contained within the circular band that extends 0.4 in. from the edge of the runner. The resulting debris locked up the shaft by filling the axial clearance (0.0024 in.) between the runner and the stators. Both units have been rebuilt with replacement shafts, thrust bearing stators and runners, journal bearing pads, labyrinth seals, and eight proximity probes. With the exception of the probes, all the damaged parts have been repaired.

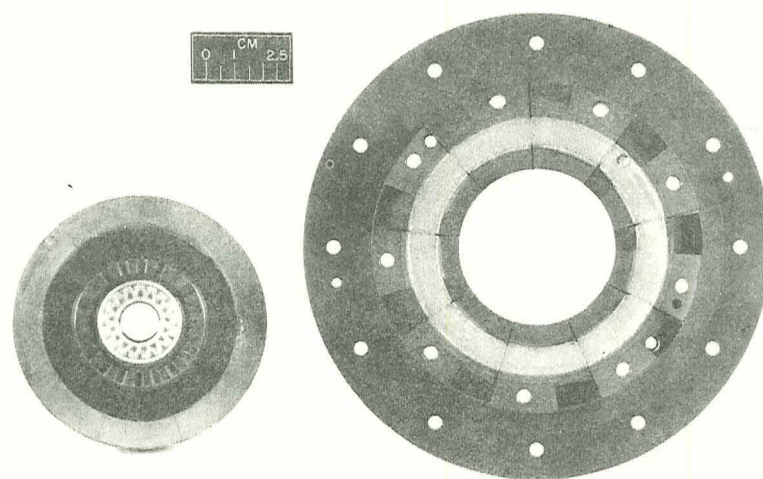
Figure 16. - Overspeed damage to thrust bearing.

Figure 16 shows the turbine side of the thrust bearing; the wear pattern on the compres-
